Marine Repair Workshops / Maintenance & Repair Solutions

Filler Materials for rebuilding and hard facing of Valves, Valve Spindles & Valve

Piston Crown -Welding Repair Solutions

CYLINDER HEADS- DIESEL ENGINE- MARINE REPAIR SHOPS

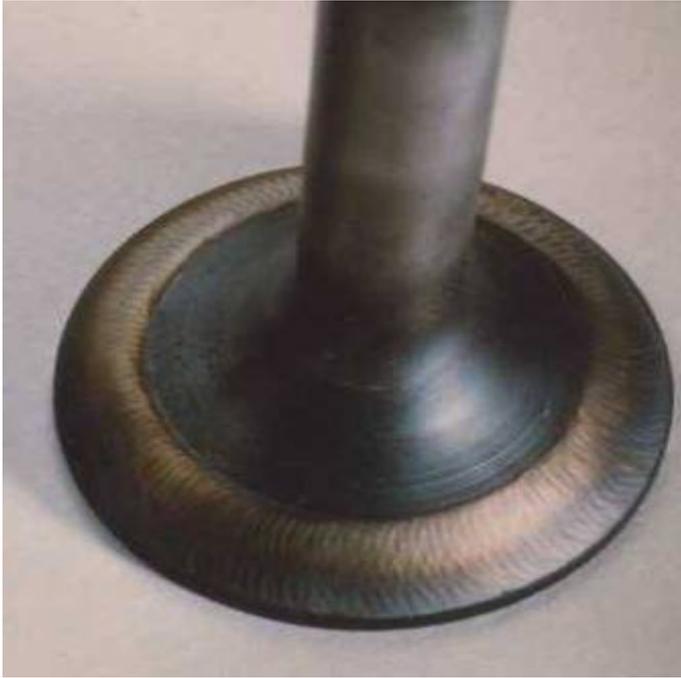
Valve seats rebuilt by GTAW Process,
Filler rod ARCWEL 625 T

Valves and Valve seats of Diesel engines are subject to wear by high temperature and metal to metal friction

- ◇ **SMAW 1 : E-625 (Ni based alloy)** as build up and or final layer (**CO6**) as final Top layer
- ◇ **SMAW 2 : E-808** as build up /E -6C- as top layer
- ◇ **GTAW: 625** as build up and or final layer/**1045 T (CO 6)** as final Top layer
- ◇ **PTA : ARCWEL 2006 PTA -Powder**

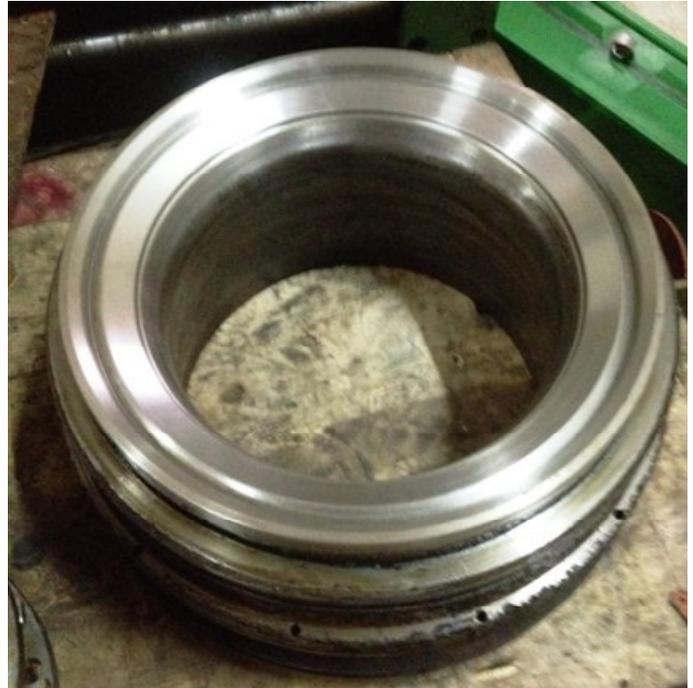
Valve coated using PTA Process

Filler: Metal powder Ni Co

“ARCWEL 2006 PTA” powder

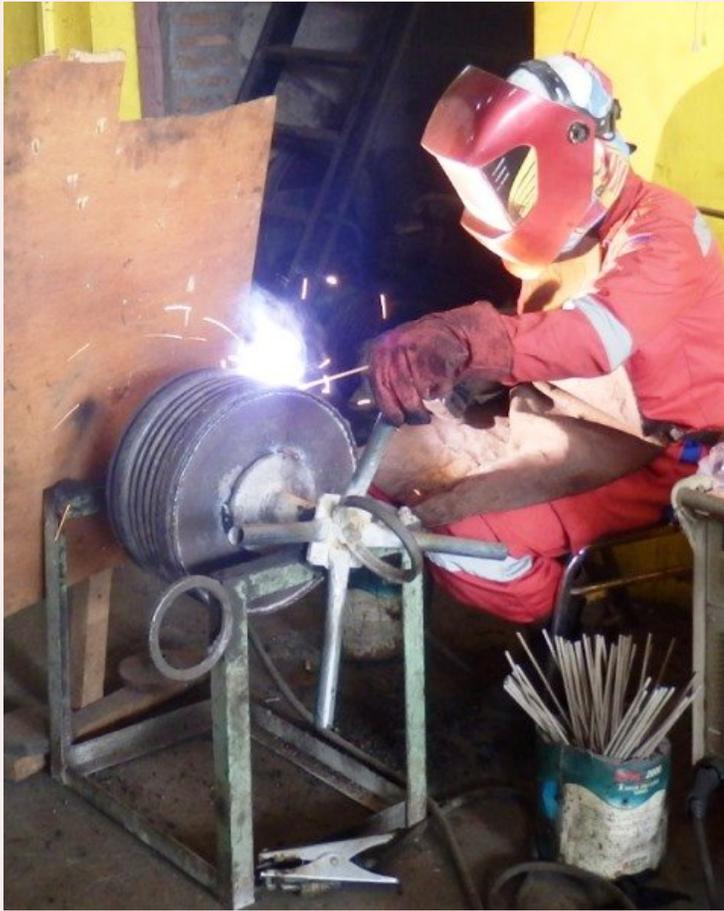
Piston Crowns made from alloy steels are subject to high temperatures ,and friction.

The surfaces tend to wear down and need to be rebuilt .

Depending on Equipment available the following filler materials are suitable for **rebuilding piston crowns**.

- Clean surface to be rebuilt by grit blasting or grinding
- Measure present size to original size
- Inspect inside and outside for cracks using ultrasonic or NDT detection.
- Remove all cracks and burnt surface by machining
- Preheat Piston crown to a temp of min 200 C and keep this preheat until welding is completed.
- Allow to cool slowly
- Stress relieving in controlled furnace according to base metal is recommended

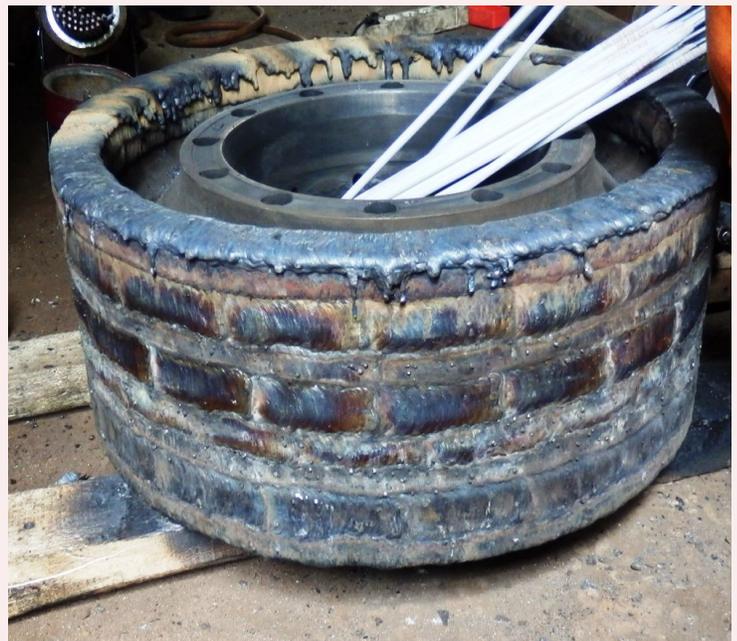
Worn Piston crown totally rebuilt using ARCWEL E -808 stick electrode

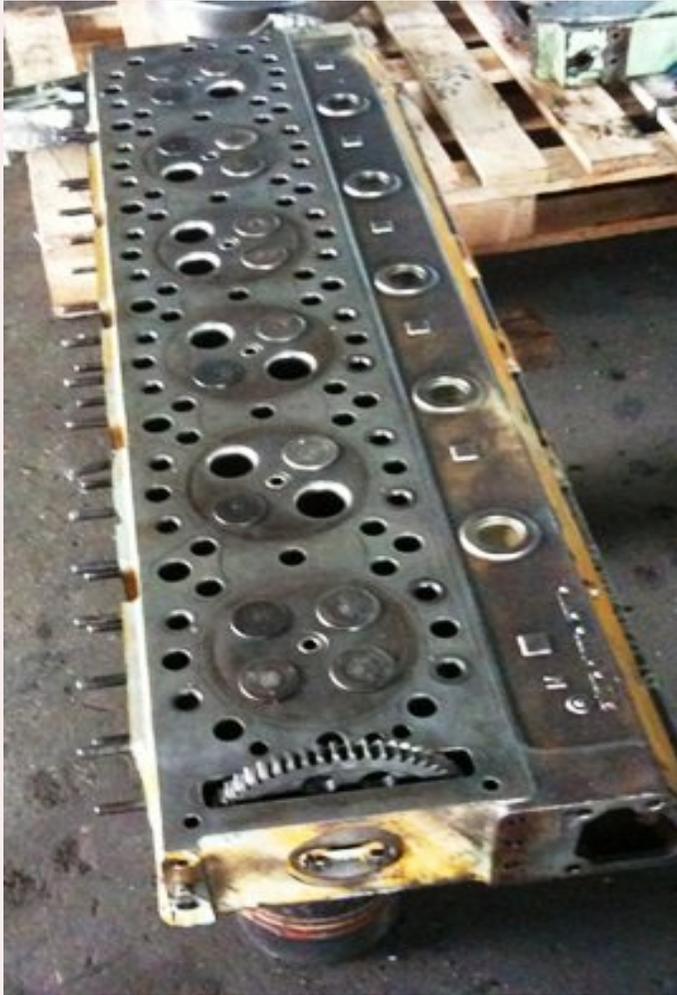
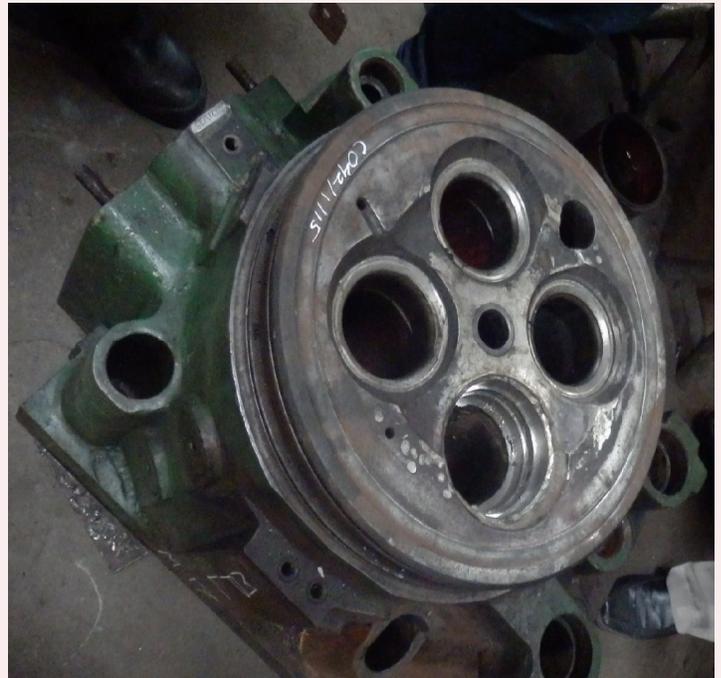
Base material : Cast Iron

Wear and possible cracks due to high temperature erosion.

Cylinder heads and Engine blocks can be repaired by using one of the following methods

- 1) **ARCWEL E-606** for cold welding of thin sections (up to 5 mm) and for best machinability
- 2) **ARCWEL E-601** for welding of thicker sections and for highest strength

Smaller cracks and surfaces/valve seats can also be repaired/rebuilt by using the TIG welding Process.
